Surface Water Plan (SWP) For City of Sierra Vista

Part 1 – Hydrology & Part 2 - Existing Conditions and Preliminary Analysis of Flood and Erosion Control Alternatives

Prepared for:
City of Sierra Vista
1011 North Coronado Drive
Sierra Vista, Arizona 85635

CMG Project #21-001
May 15, 2023

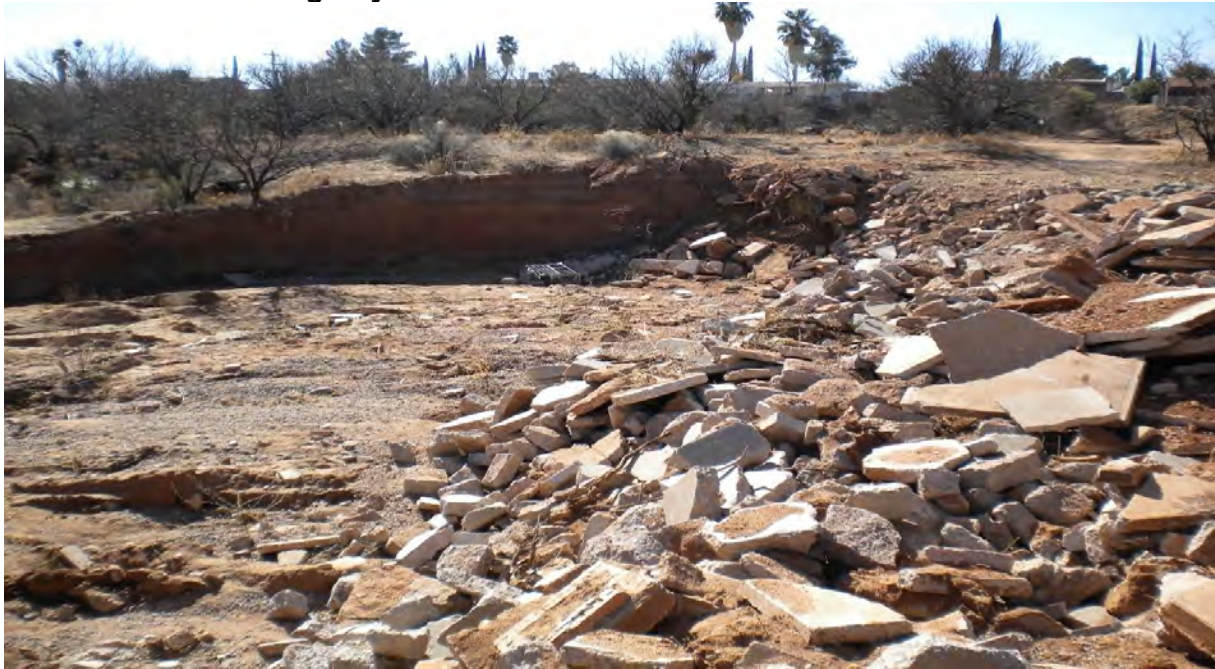
The figure below shows an example of degradation along Coyote Wash about one-third mile downstream of Foothills Drive. The City identified the necessity to place temporary erosion control measures (broken concrete) to prevent headcutting from propagating into the upstream reach where bank protection and a sewer line crossing of the wash are located.

Channel Erosion along Coyote Wash

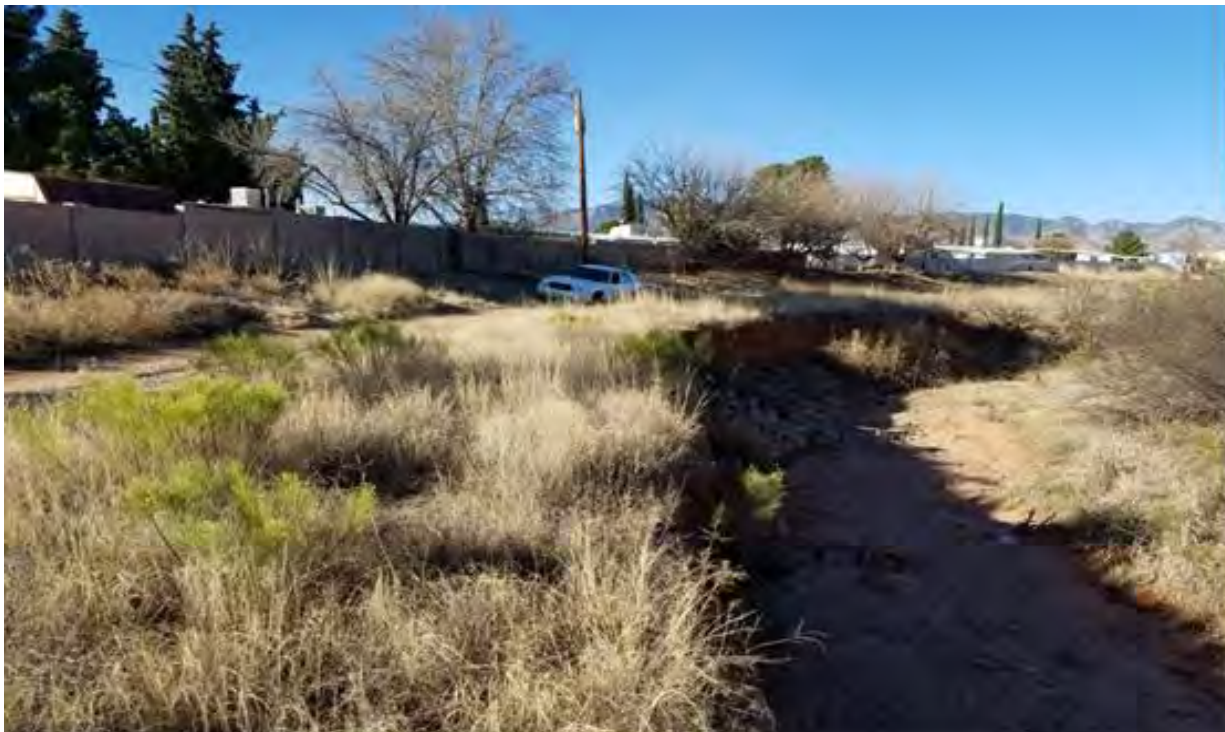
Bank erosion is also evident at several locations particularly where degradation has occurred. One such example is along the 3rd Street drainageway between Fry Blvd. and Lenzner Avenue where gradual bank erosion threatened a regional sewer line. The City installed about 165 feet of gabion bank protection to mitigate this threat.

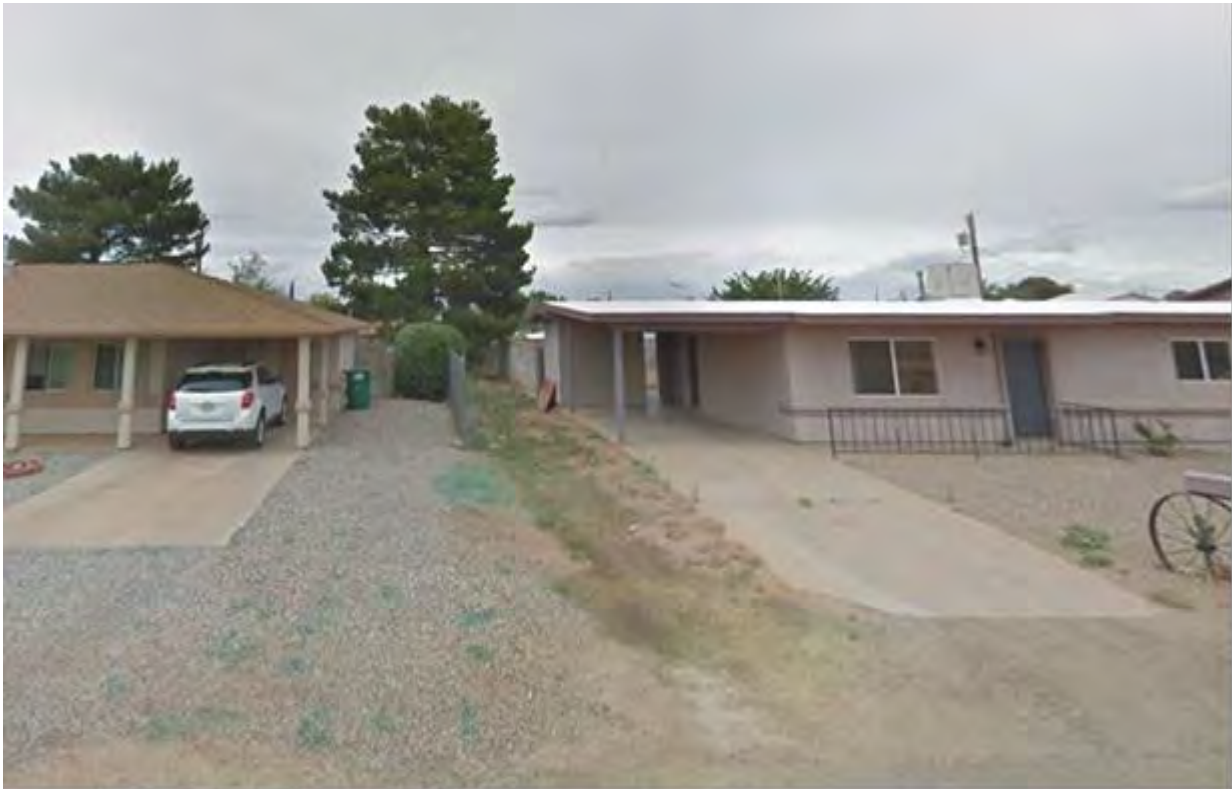
Figure 4.1.2 - Timothy Ln –Sulger Subdivision Drainage Swale between Residential Lots

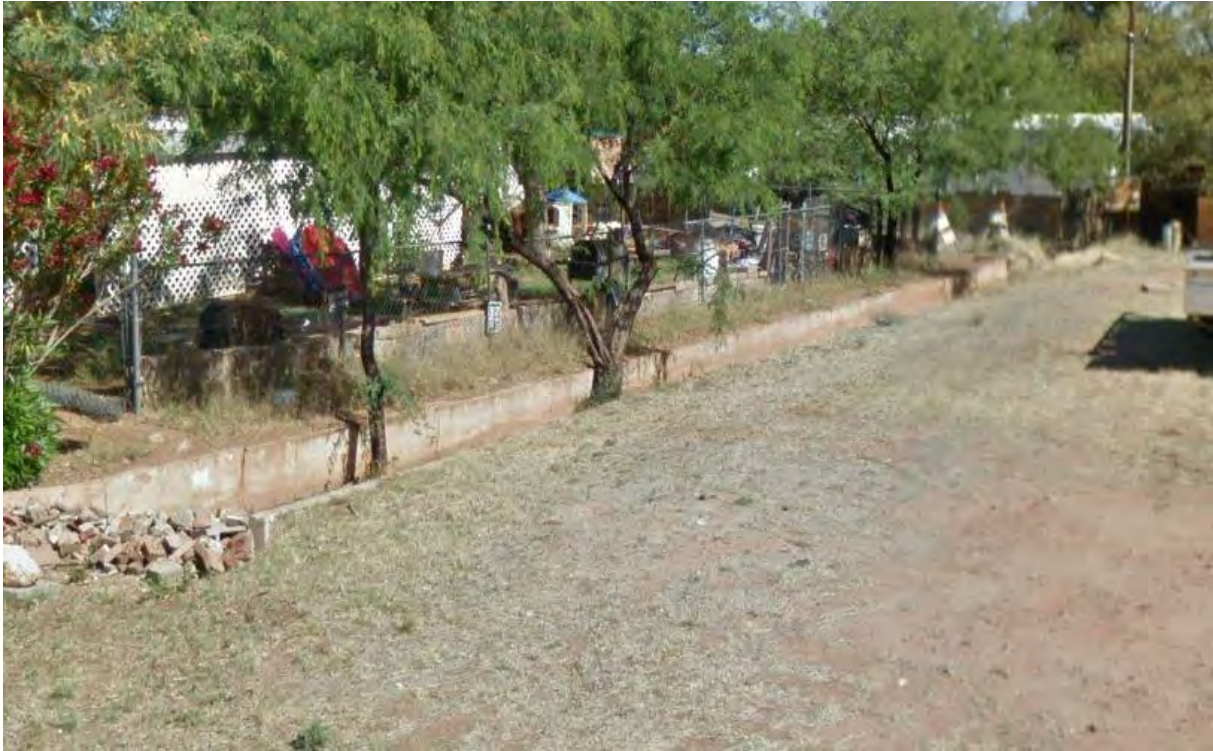
Figure 4.1.3 - Jennifer Ln –Sulger Subdivision Drainage Ditch between residential lots

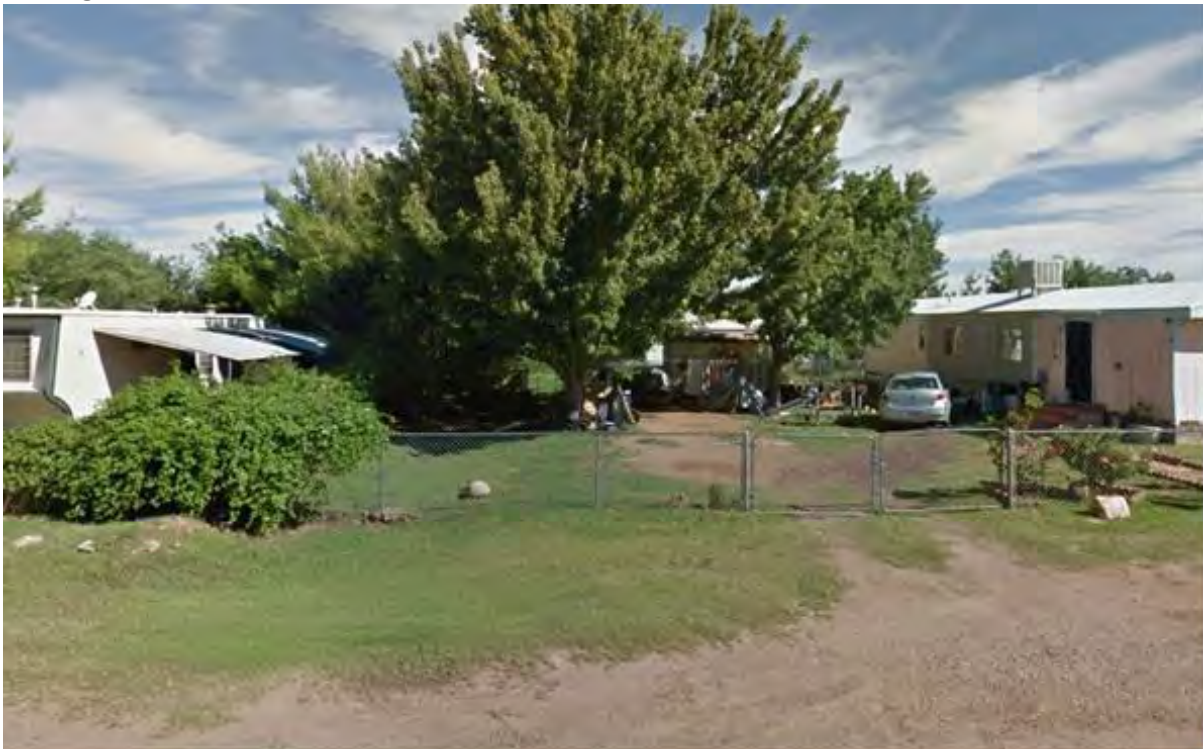
Figure 4.1.4 - Danny Lane – Sulger Subdivision Typical area of surface drainage through residential lot

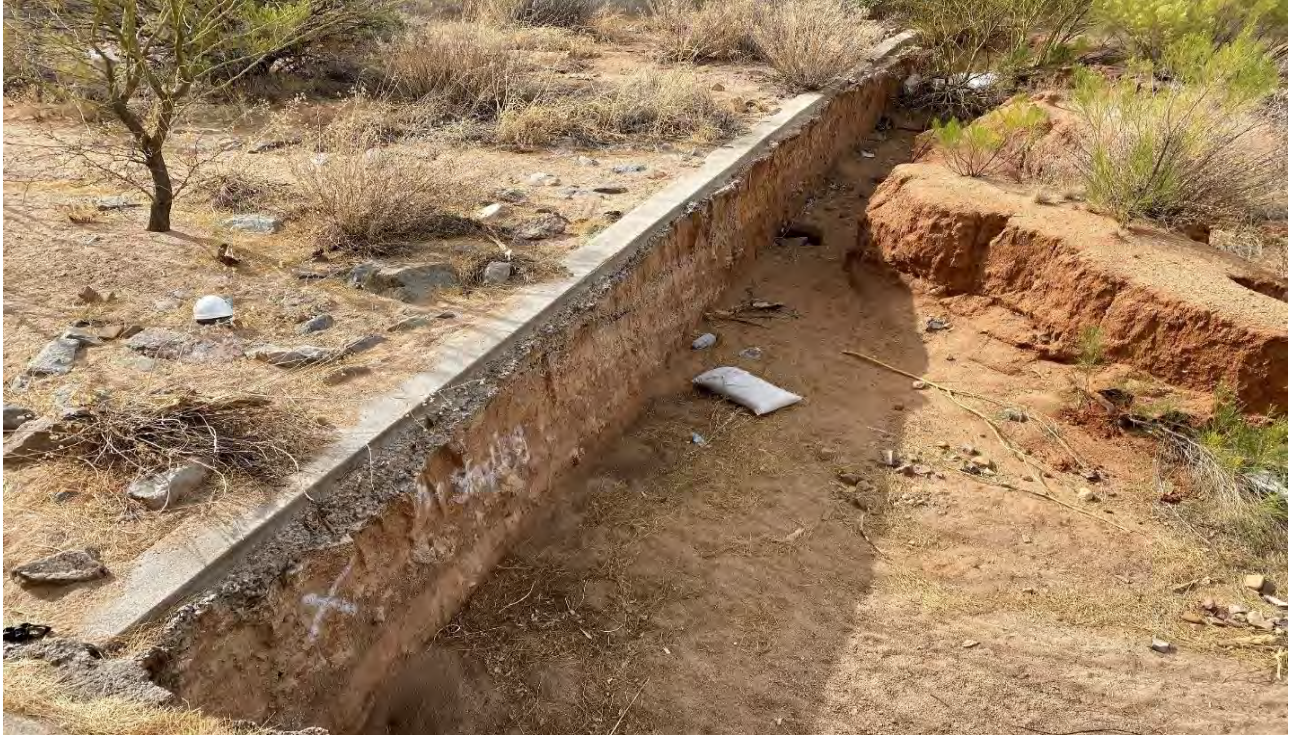
Figure 4.4.1 - Kings Manor Wash Grade Control at Savannah Springs Apartments

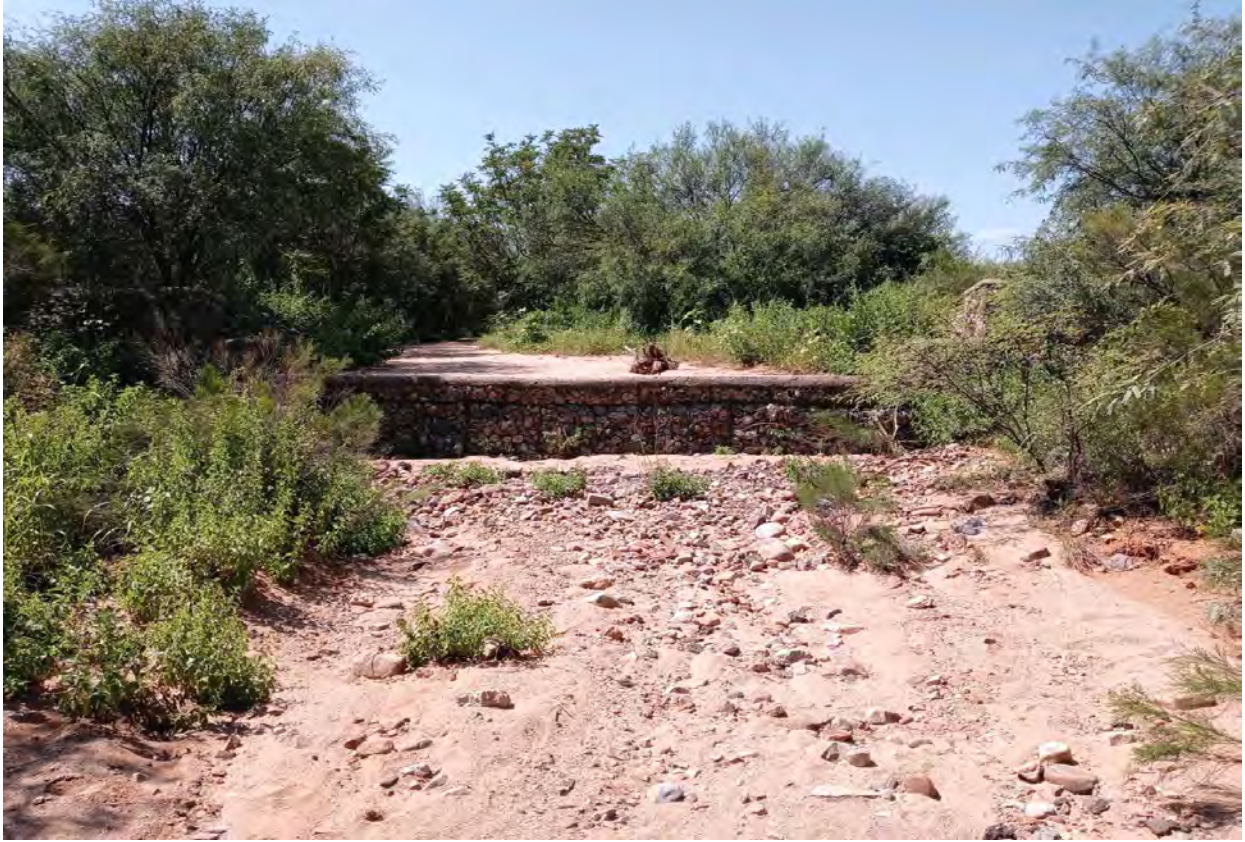
One of the factors important to the stability of the grade control at Savannah Springs Apartments is the stability of another grade control structure located about 800 feet downstream. This structure was installed to protect a sewer line crossing of the wash (see Figure 4.4.2 below). Field inspections found this grade control to be in good condition.

Figure 4.4.2 – Kings Manor Wash Grade Control located about 150-feet Upstream (south) of SR-90

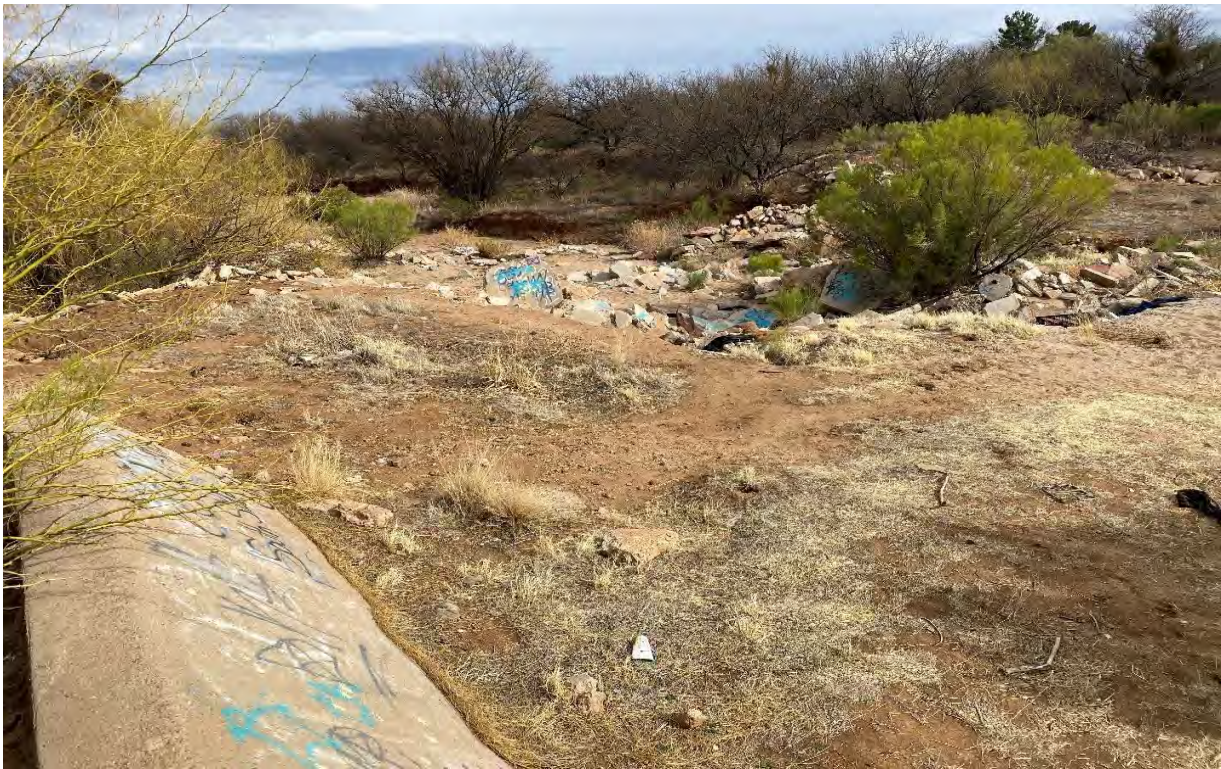
Figure 4.5.1 - Coyote Wash Headcut at Sewer Line Crossing 1940-ft downstream of Foothills Drive

FIGURE 9.9 – Plan View of Proposed Grade Control Structure at Coyote Wash Sewer Line Crossing

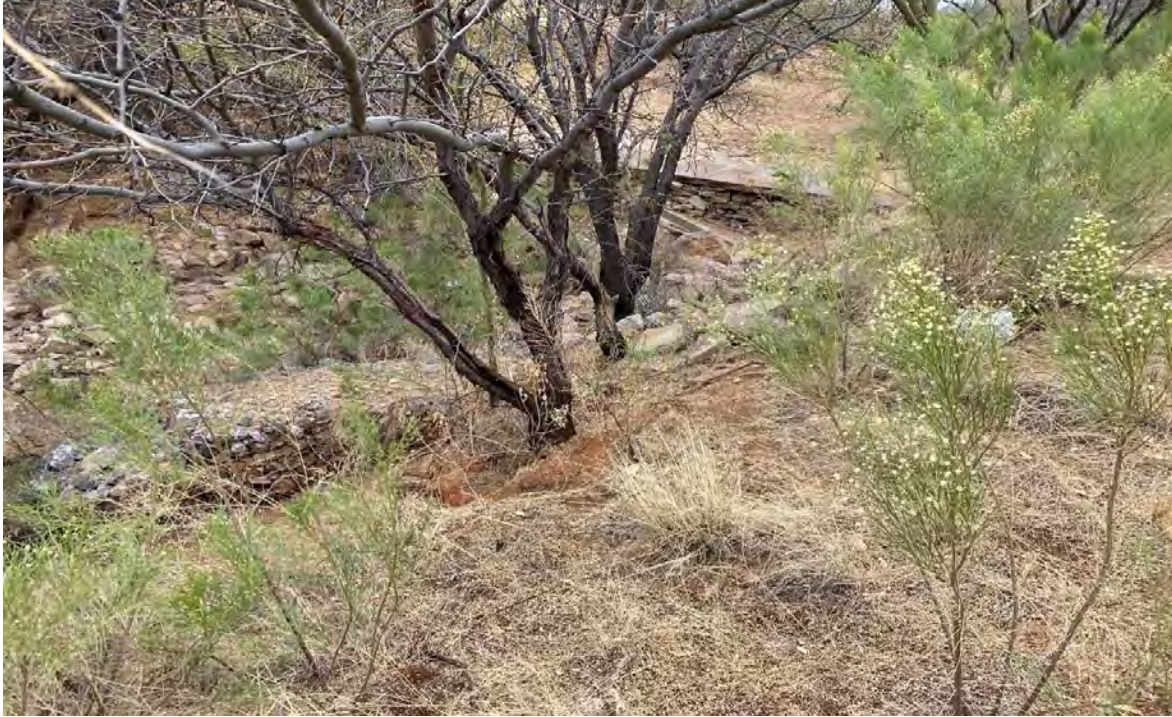
Figure 4.6.1 - Woodcutters Wash Headcut near across from the 7th St./Savannah Dr. Intersection

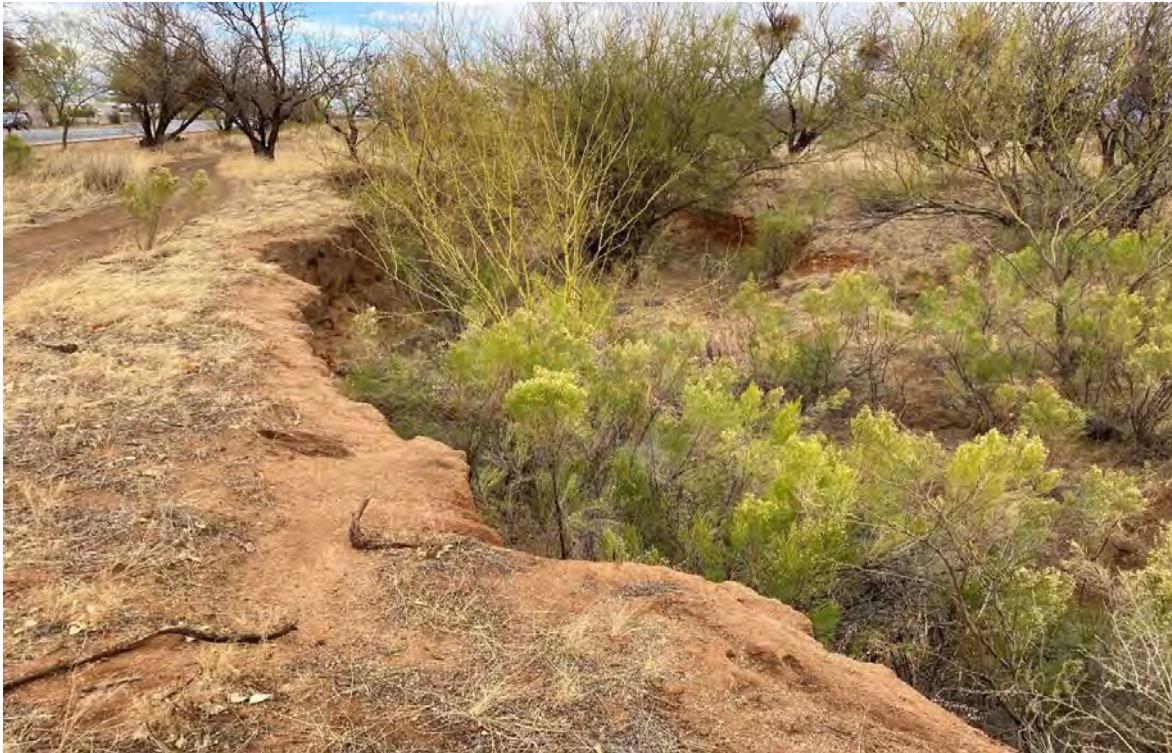
Figure 4.6.2 - Woodcutters Wash Headcut Downstream of Grade Control near 7th Street/Savannah Drive Intersection

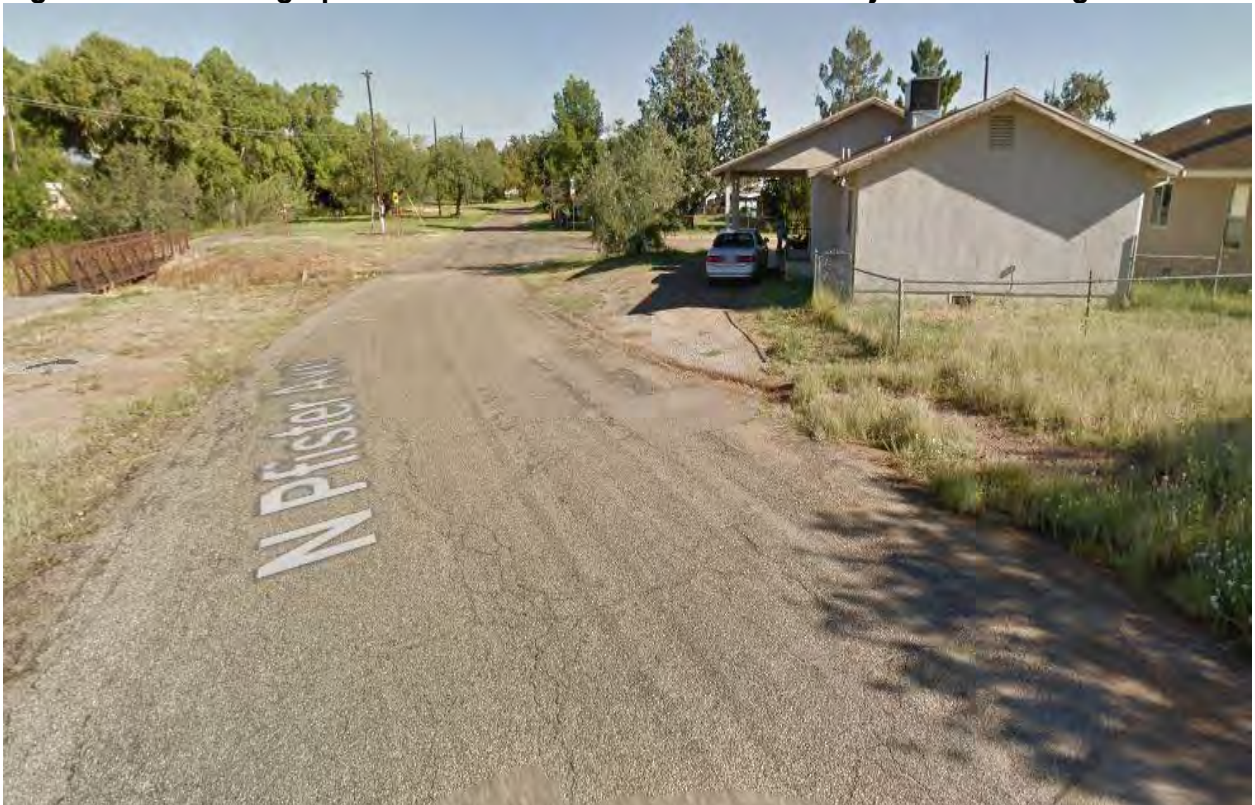
Figure 4.7.1 - Photograph of Soldier Creek Overbank Area Subject to Flooding

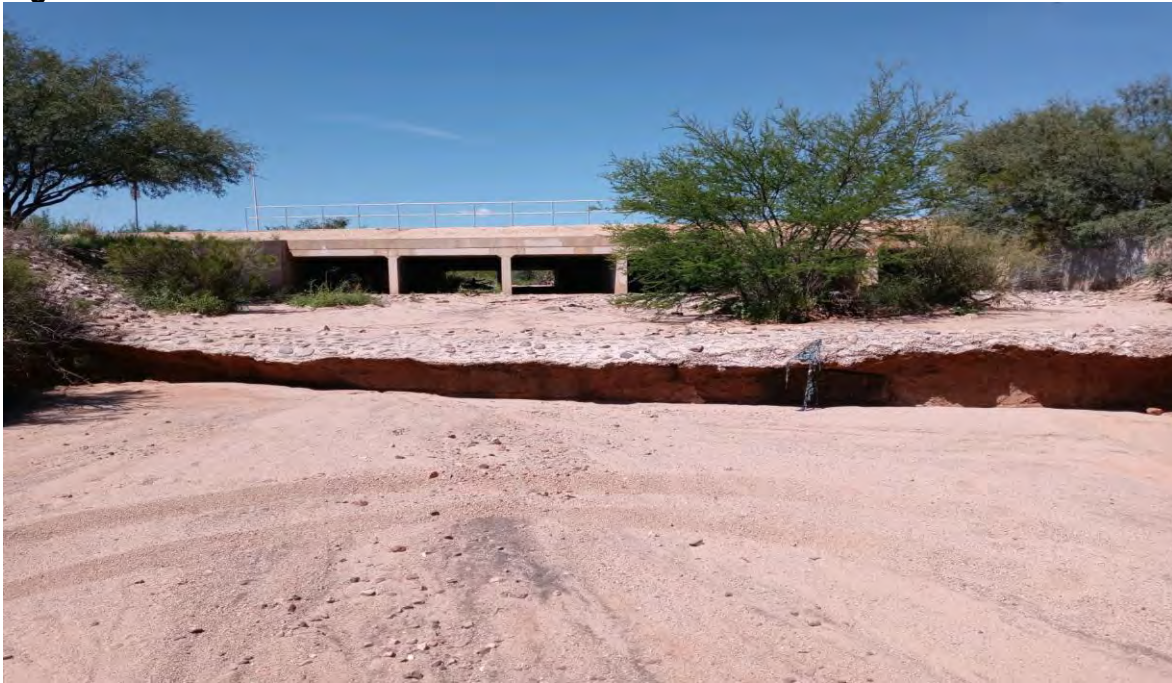
Figure 4.8.1 - Charleston Wash downstream of Colombo Avenue

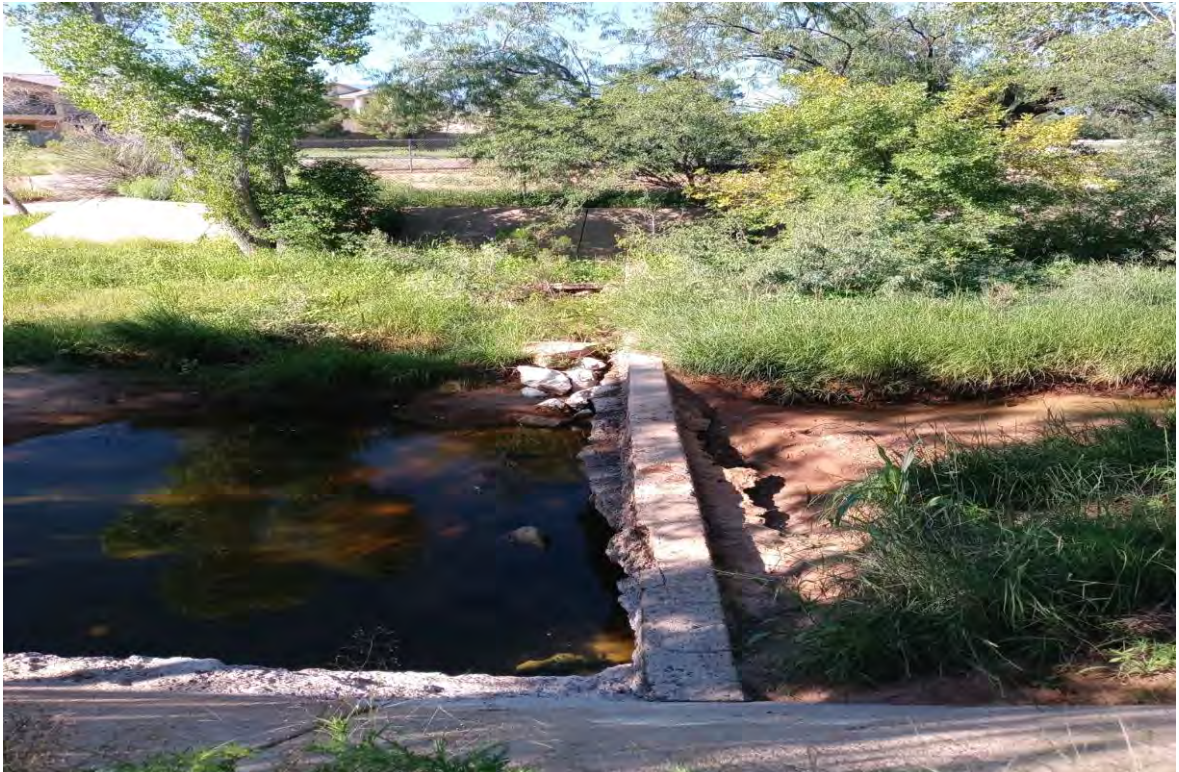
Figure 4.8.4 - 3rd Street Drainageway about 200-feet upstream of the Woodcutters Canyon Wash Confluence

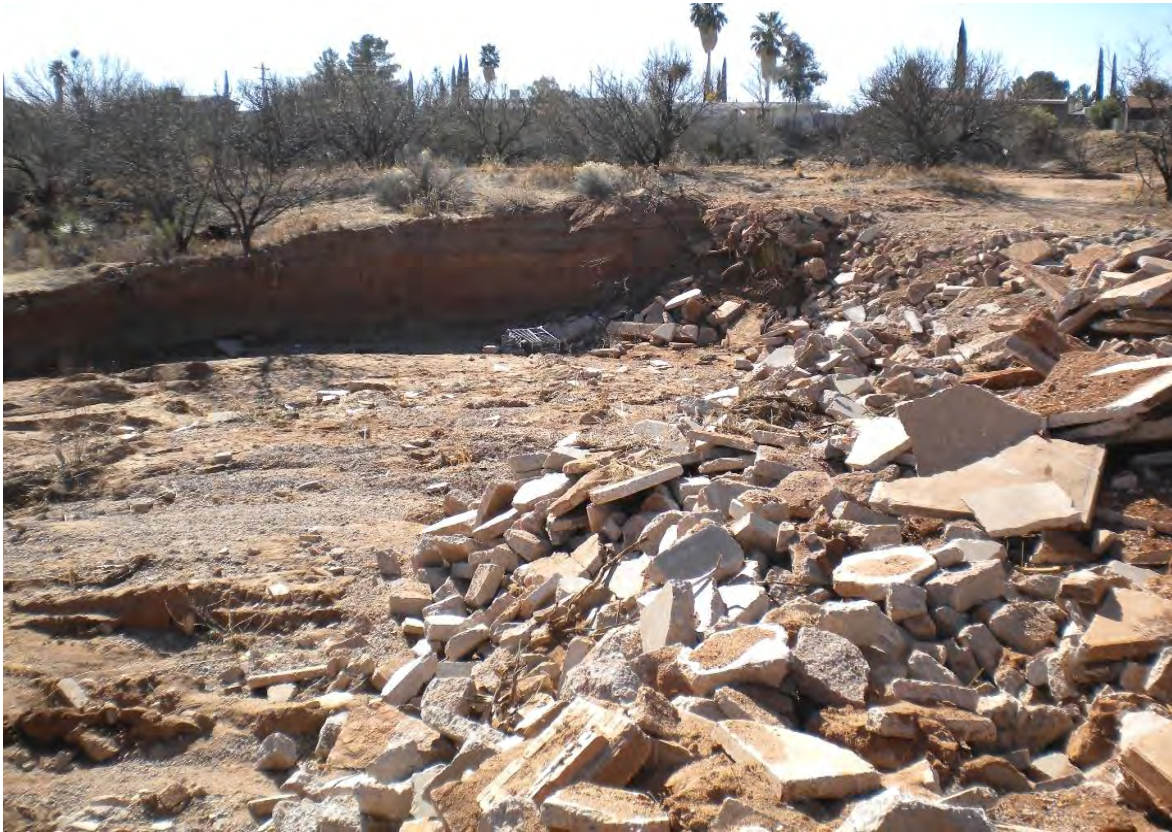
Figure 5.1.1 - Headcut along Coyote Wash Downstream of Foothills Drive

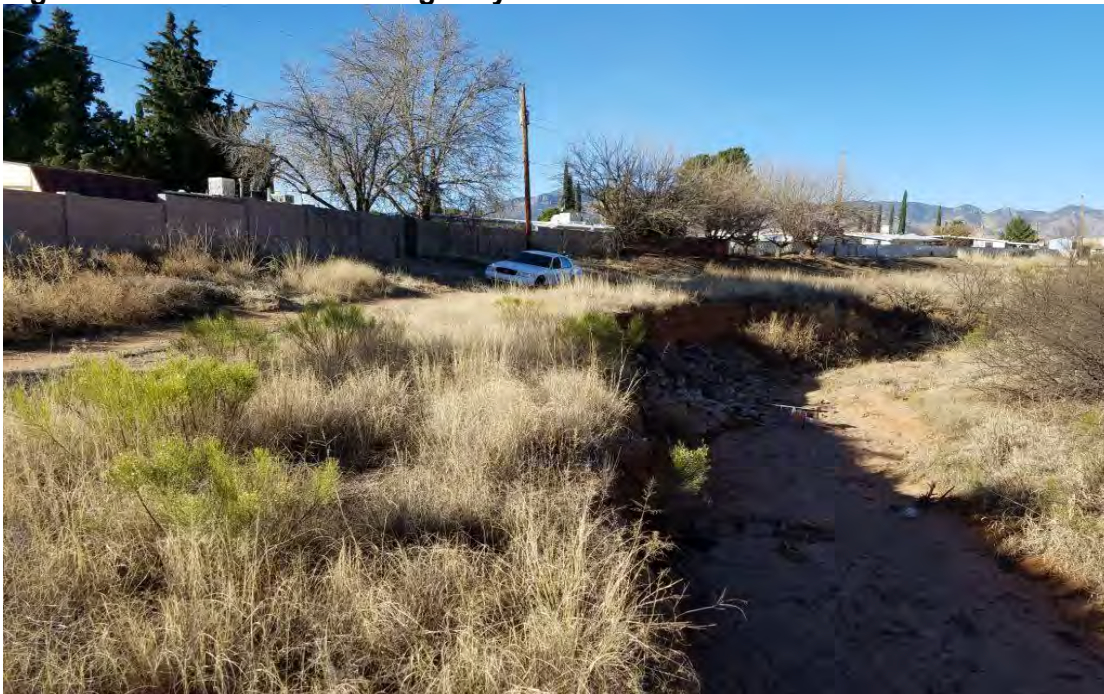
Figure 5.1.2 - 3rd Street Drainageway Bank Erosion near Sewer Line

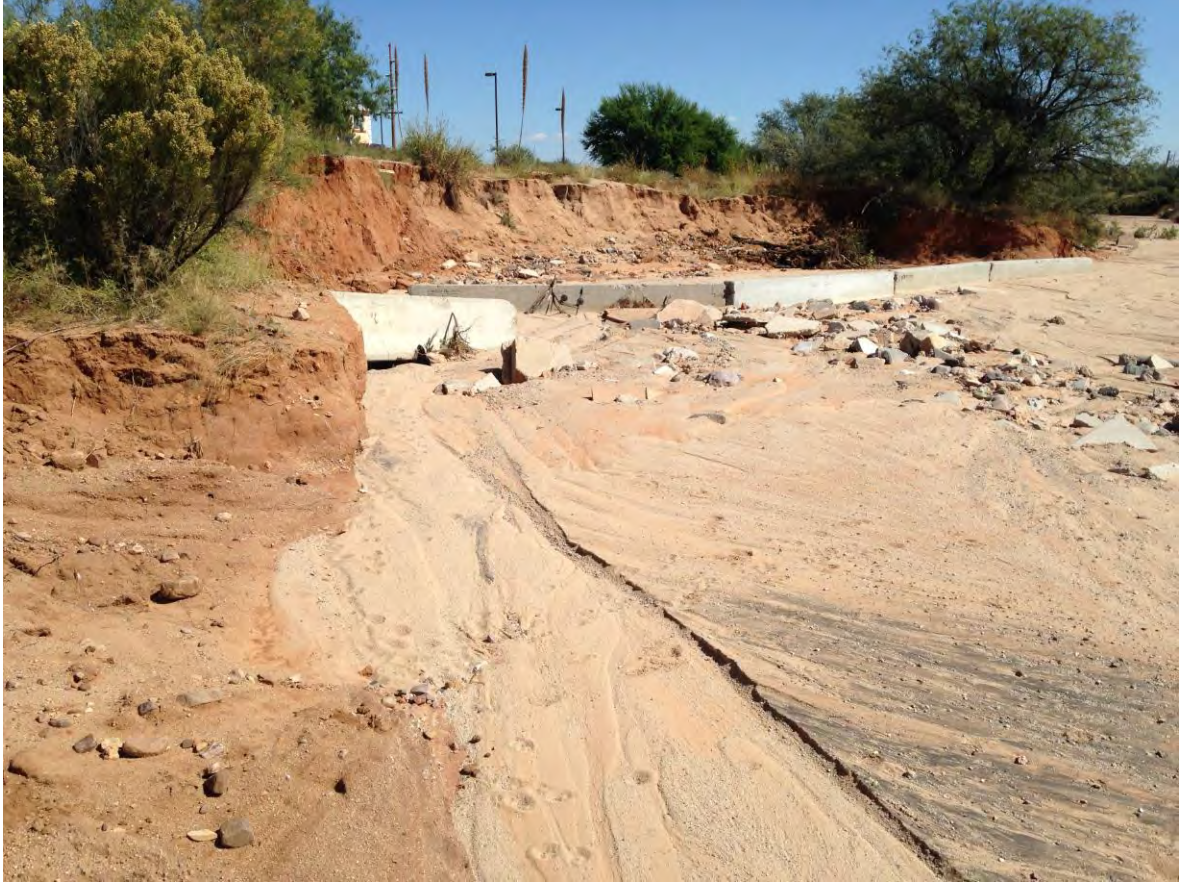
Another example of significant bank erosion is along Charleston Wash in the vicinity of the Port Royale Apartments (APN#10716011N) where erosion at a meander bend resulted in the loss of 30- to 50-feet of bank where landscape improvements were located (see Exhibit below).

Figure 5.1.3 - Charleston Wash Bank Erosion at Port Royale Apartments

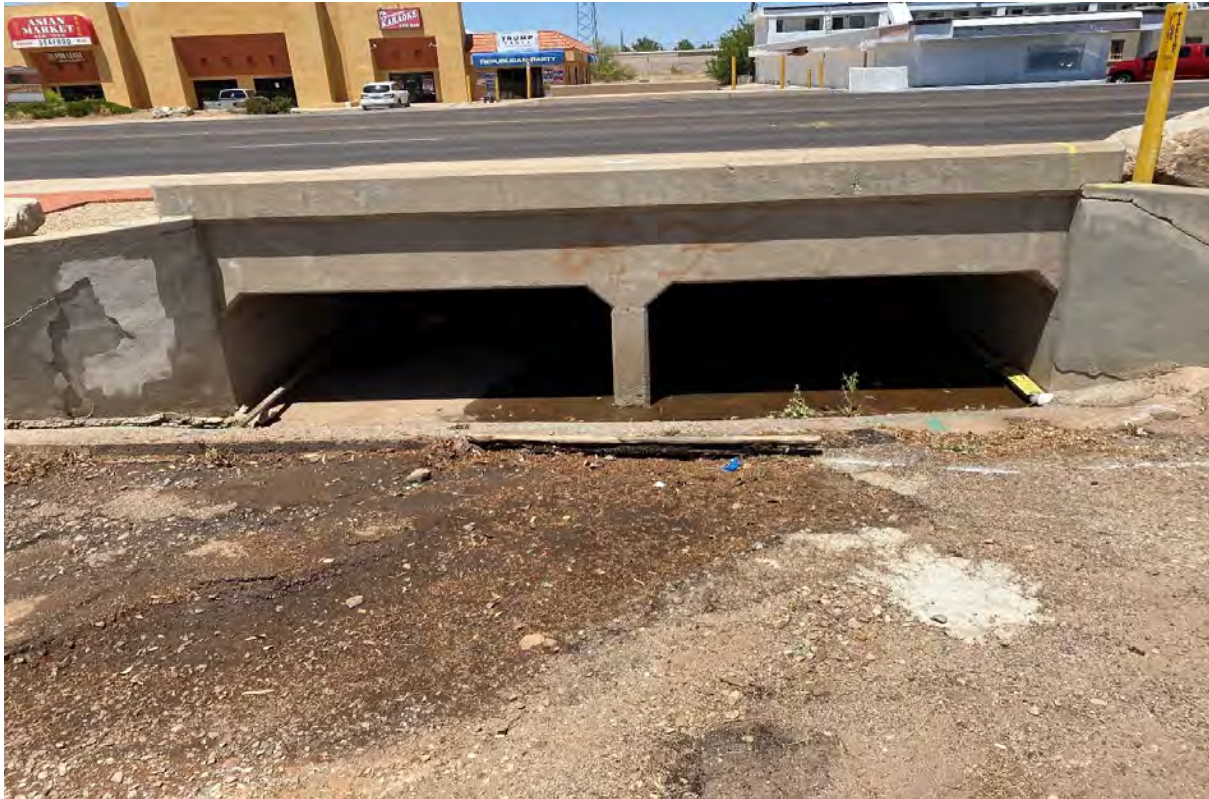
Figure 9.1- Two Cell 8' x 3' Box Culvert beneath Fry Blvd.

Flow leaving the Fry Blvd. culvert drains across a parking lot then between two commercial buildings via a driveway. After passing between two commercial buildings on the north side of the street, flow discharges into a man-made earthen channel that collects stormwater then drains it east toward North Avenue. A culvert beneath North Avenue discharges flow into a detention basin (hereafter referred to as the North Avenue Detention Basin). This basin presently has a capacity of about 4.5 acre-feet at top elevation. There is a 48-inch outlet culvert set at basin invert elevation along with an emergency spillway at 8.5-feet above basin invert to discharge flows at a reduced flow rate. Calculations completed as a part of this study determined that the 100-year storm peak inflow rate of 207 cfs is only reduced to 188 cfs at the basin outlet.

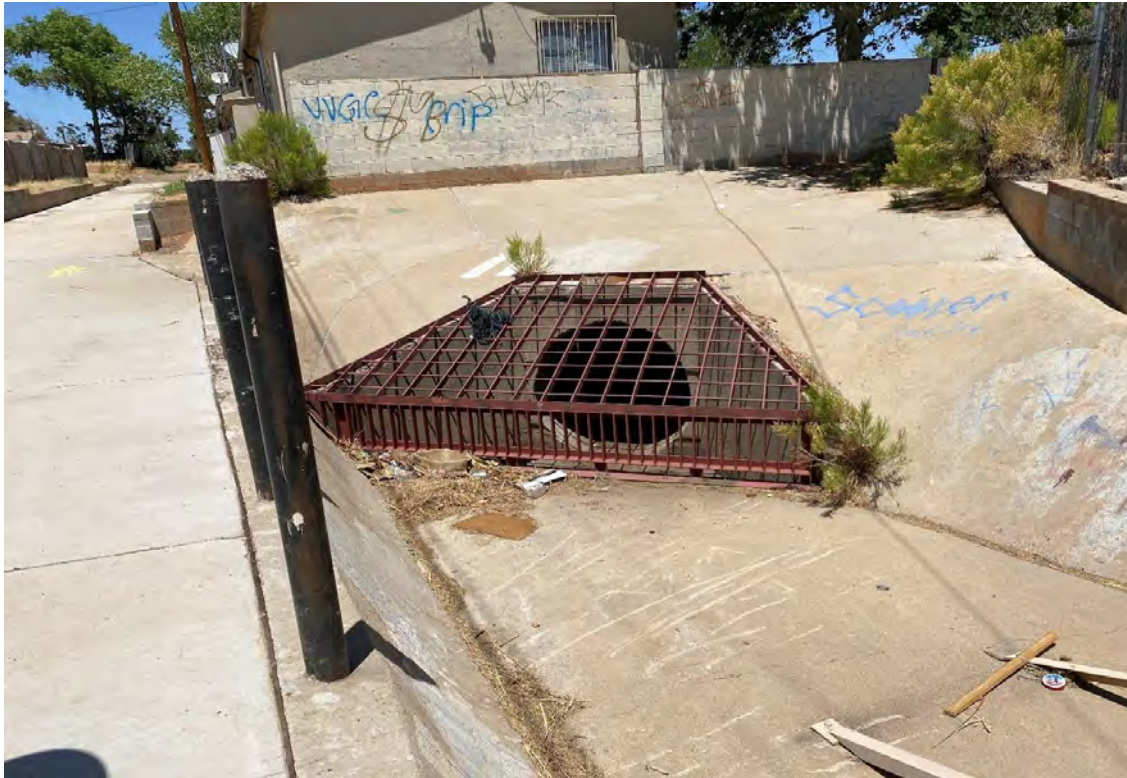
Figure 9.5 - Inlet to 66-Inch Storm Drain Connecting Fab Ave Drainageway to Vista Village Drainageway

The storm drain described above varies in diameter from 66-inches at the inlet to 78-inches at the outlet on 2nd Street north of Theatre Drive and is a corrugated metal pipe according to the plans prepared by Cella Barr and Associates. The total length of the storm drain is about 1600-feet. Construction plans for this storm drain were prepared by Cella Barr Associates in 1991. The capacity of this storm drain is estimated to be between 100 and 130 cfs, although that is not necessarily the available capacity at the Fab Avenue inlet since there are other inlets downstream thereof. A copy of the plans can be accessed from the electronic database developed in conjunction with this SWP update.

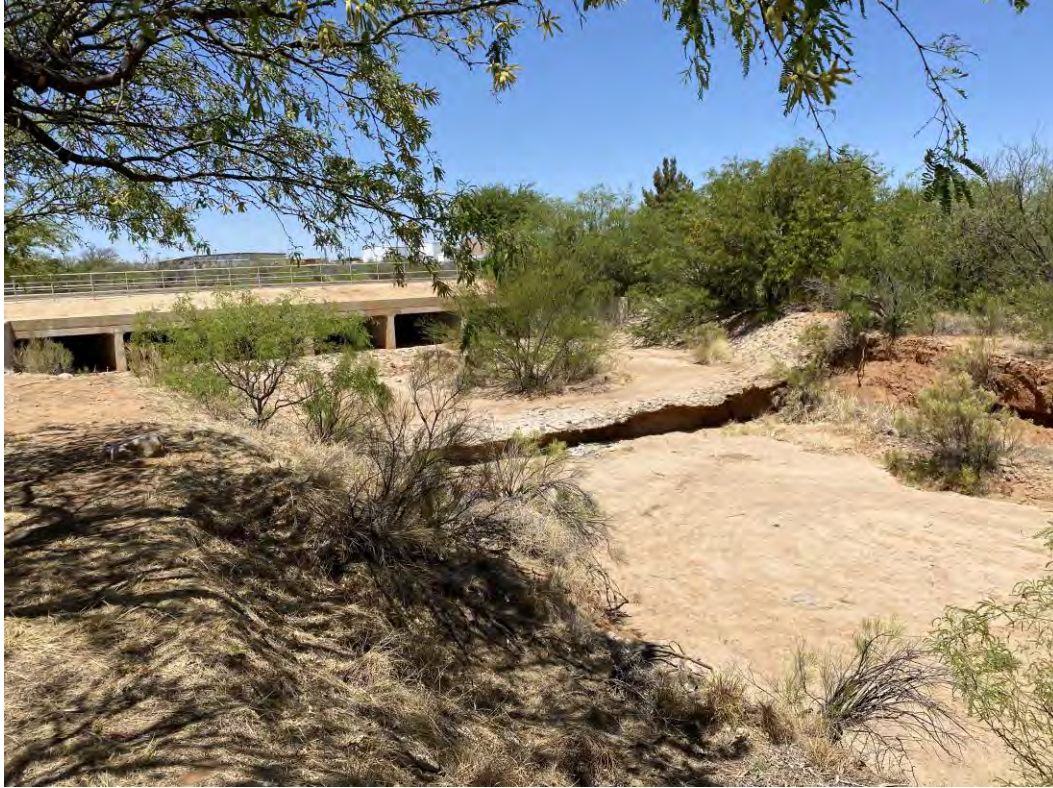
FIGURE 9.18 - Colombo Avenue Culvert Outlet

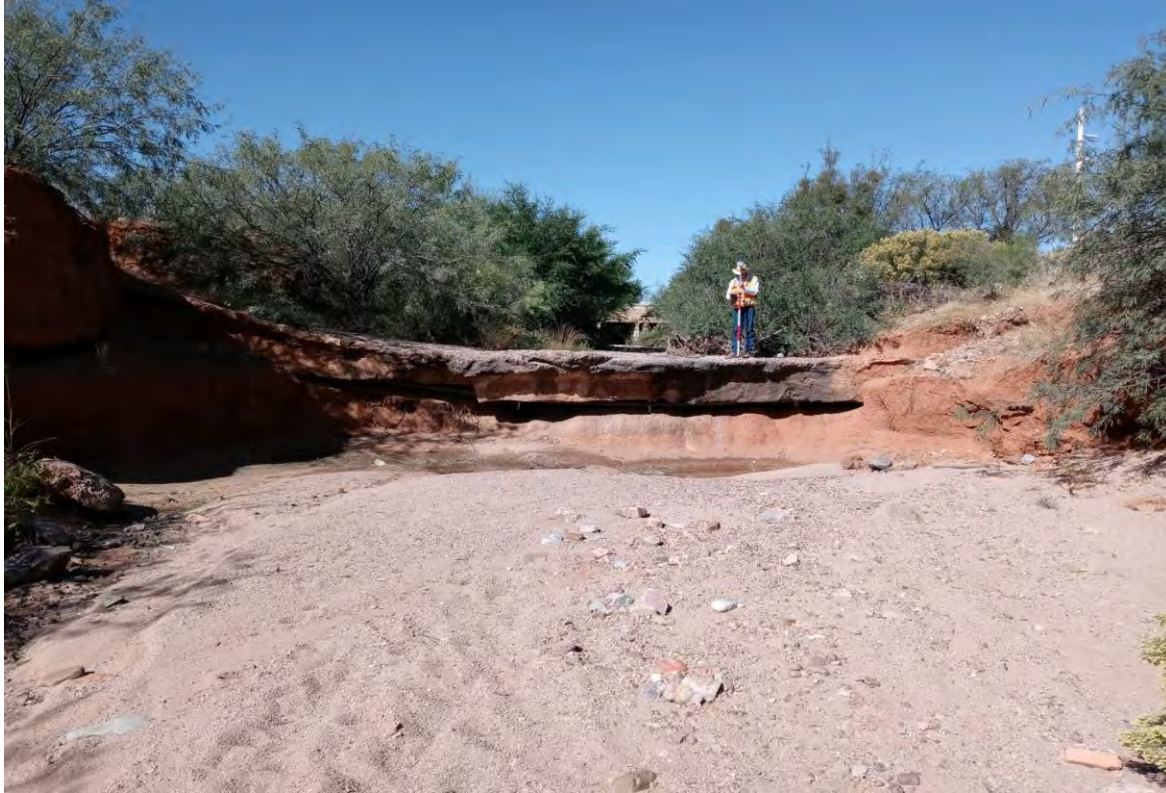
Figure 9.22 - Existing Grade Control 200-ft Downstream of Coronado Dr

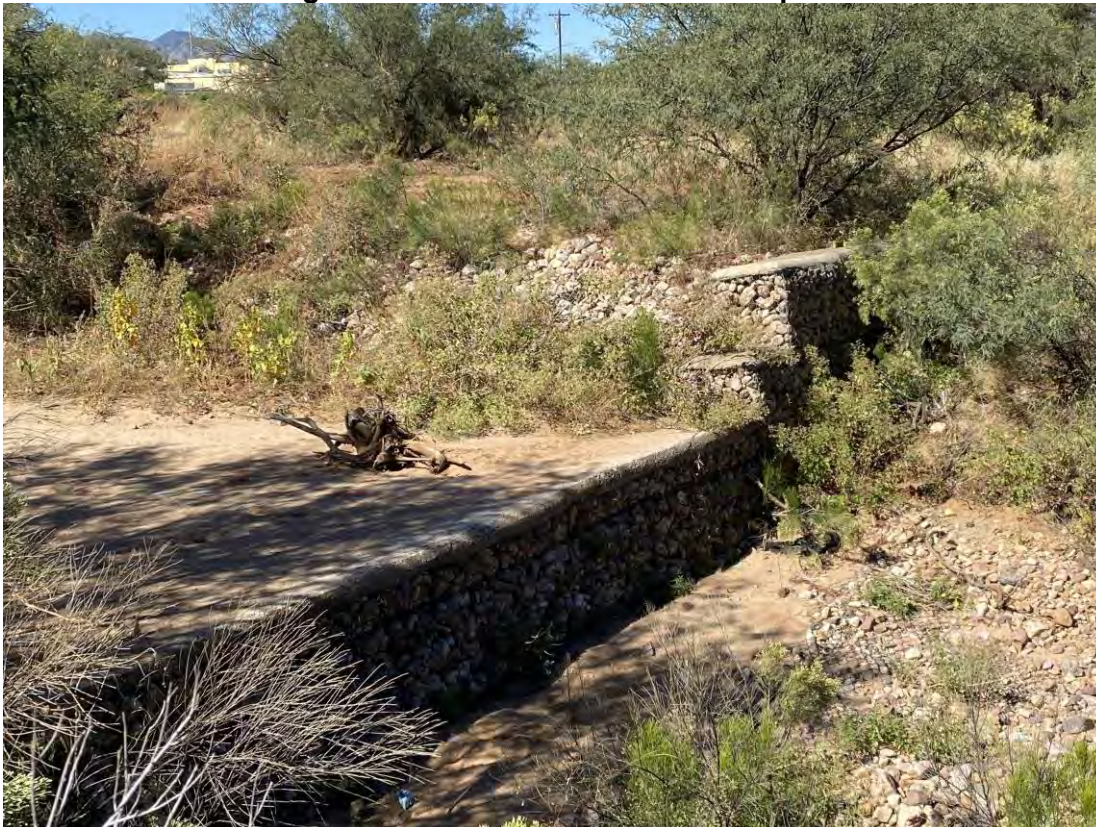
FIGURE 9.29 - Existing Grade Control Structure 140-ft Upstream of SR-90

The existing grade control is beginning to fail so additional measures are needed to stabilize it (see Figure 4.9.1 for photograph of the existing grade control). The recommendations for a new grade control at this location are shown on Figure 9.31. The recommendations include a concrete lined spillway constructed on a 3:1 slope from existing channel invert elevation at the top to the estimated long-term degradation elevation at the toe. Three-foot deep toe walls are needed at both ends to prevent scour from undermining the structure, and a 30-foot long grouted riprap apron is also needed at the downstream end for the same purpose. Gunite lined bank protection should be installed along the full length of the improvements to prevent bank erosion from outflanking the grade control. Five-foot bank protection key-ins should also be provided at the upstream and downstream ends of the bank protection.
