Surface Water Plan (SWP) For City of Sierra Vista

Part 1 – Hydrology & Part 2 - Existing Conditions and Preliminary Analysis of Flood and Erosion Control Alternatives

Prepared for:
City of Sierra Vista
1011 North Coronado Drive
Sierra Vista, Arizona 85635

CMG Project #21-001
May 15, 2023

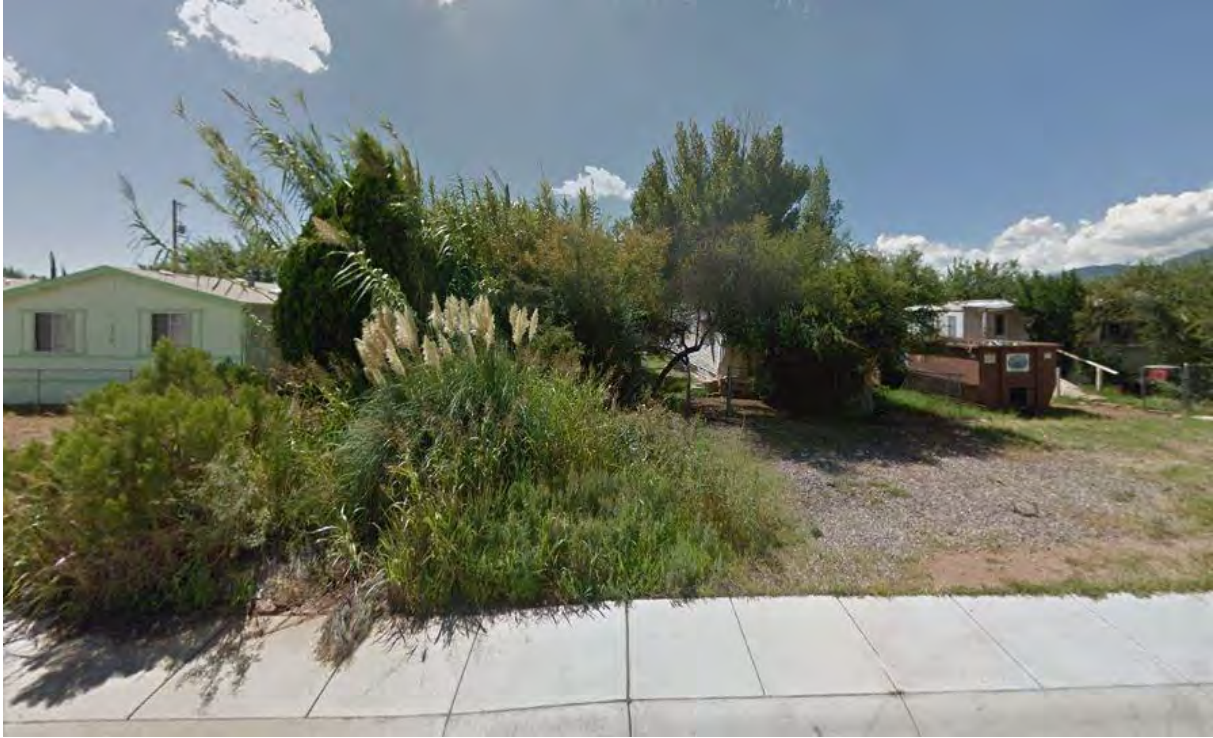
Figure 4.1.5 - Busby Drive - Sulger Subdivision Typical area of surface drainage through residential lot

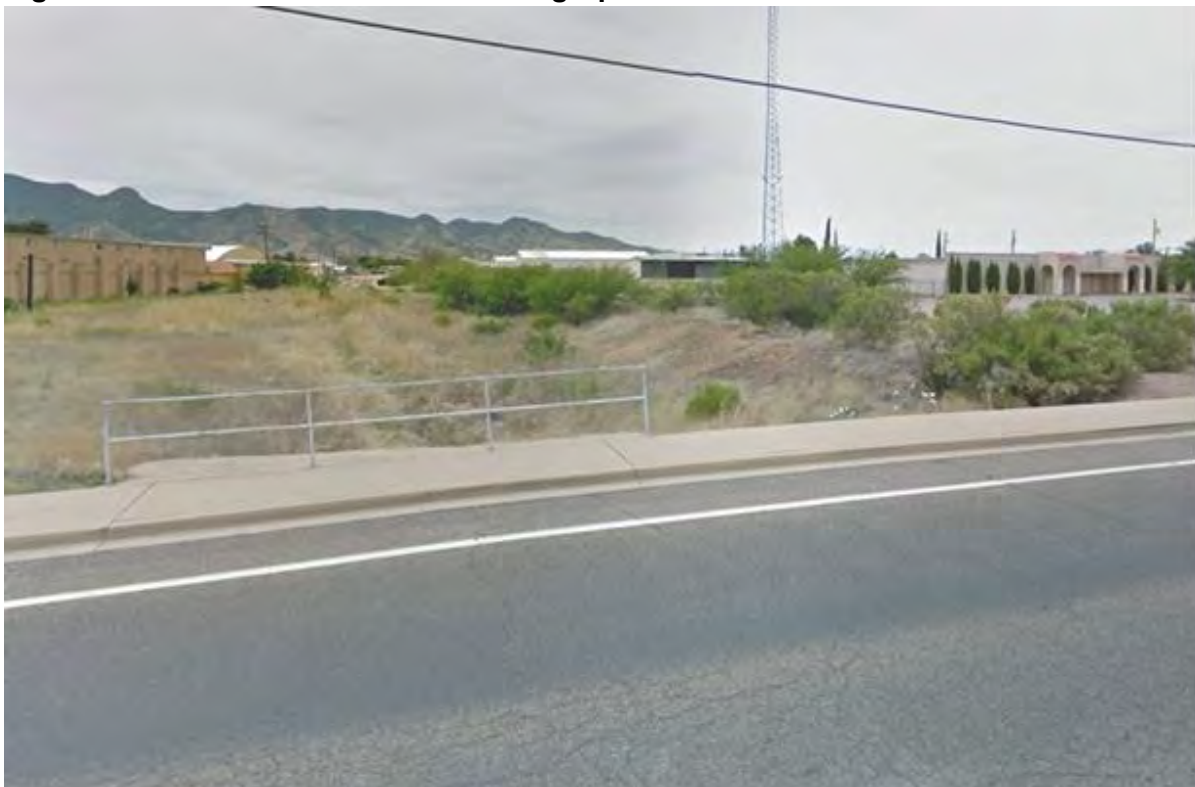
Figure 4.2.2 - Fab Avenue Wash Looking Upstream from North Street

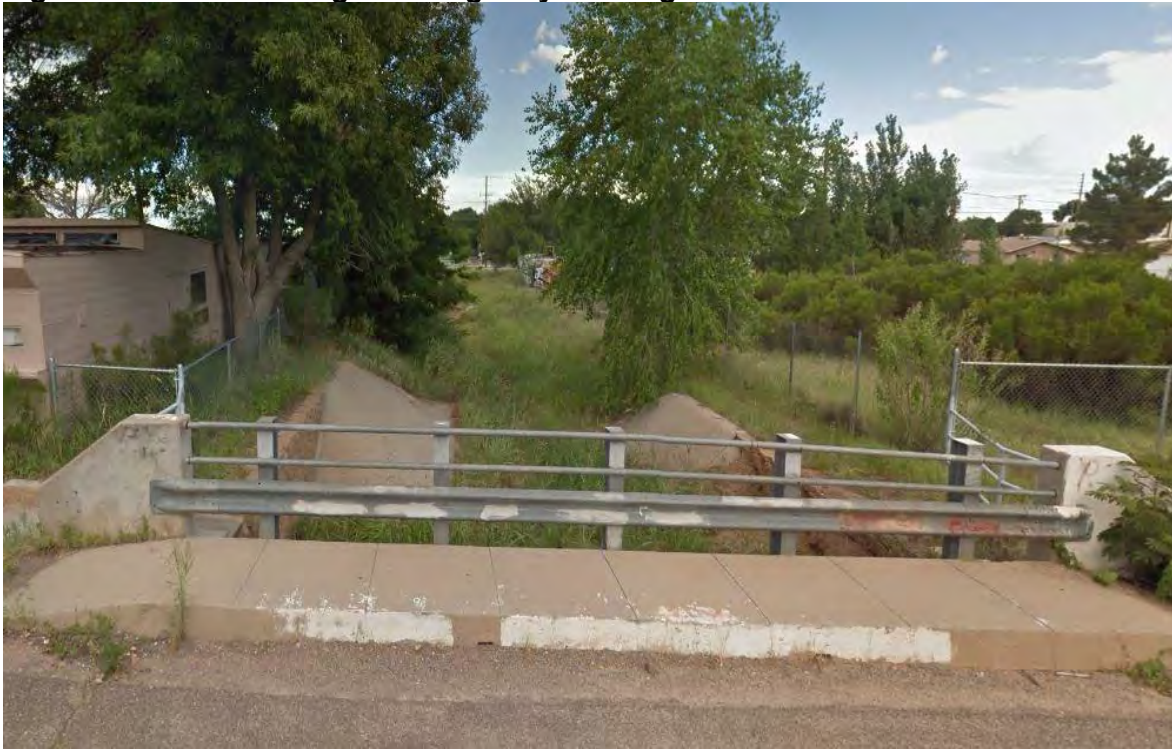
Figure 4.2.5 - Vista Village Drainageway Looking Downstream from 6th Street

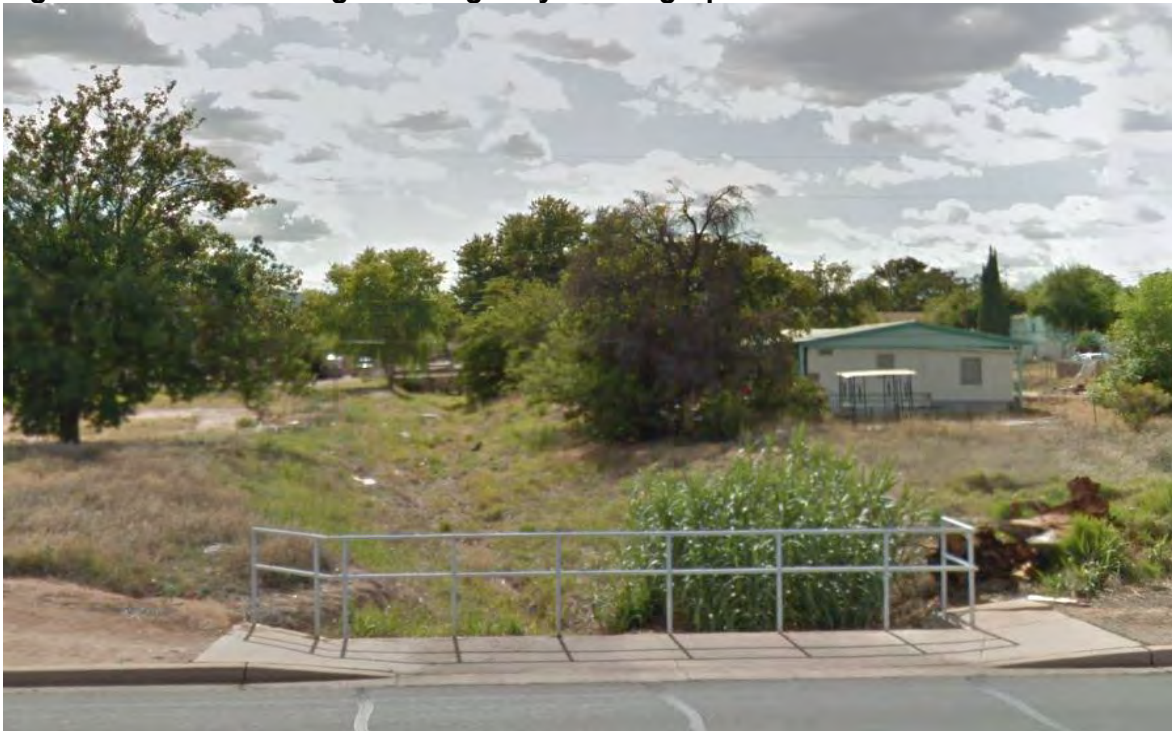
Figure 4.2.6 - Vista Village Drainageway Looking Upstream from 7th Street

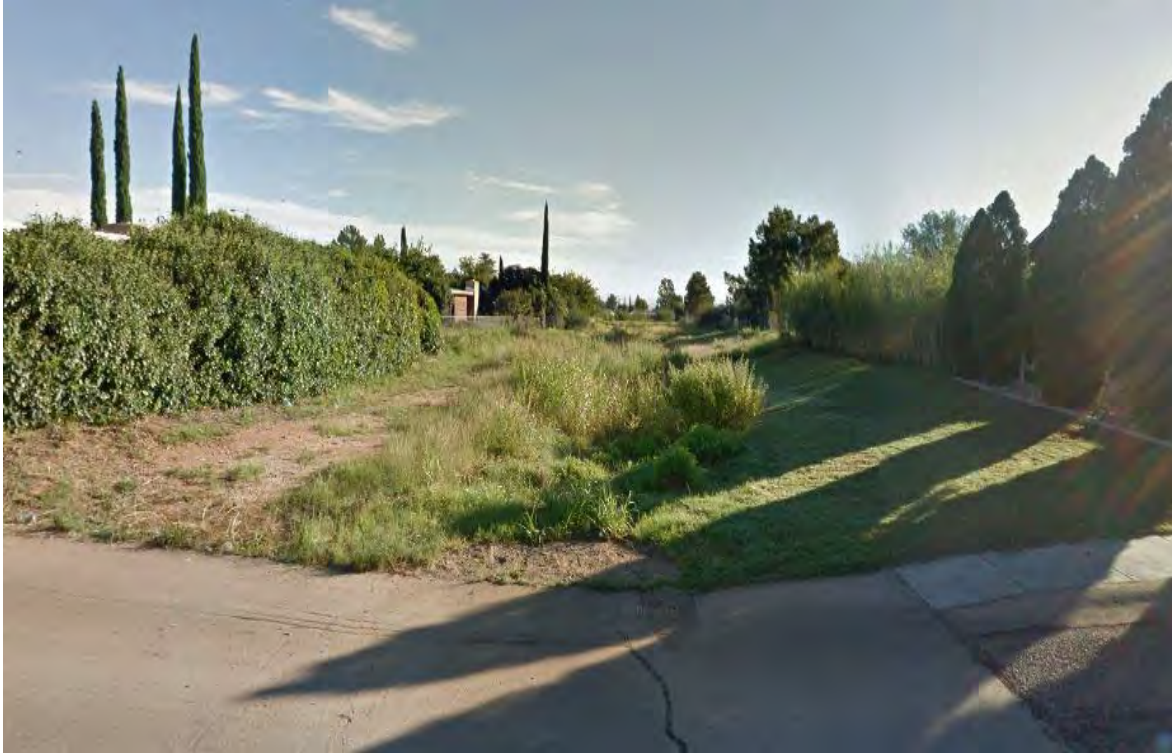
Figure 4.2.7 - Vista Village Drainageway Looking Downstream from Catalina Drive

although damages to the channel or roadway are not imminent if regular maintenance of the existing riprap and broken concrete occurs. The existing channel slope downstream of Catalina Drive is about 1.4%; equilibrium slope was computed to be 1.1%. Long-term degradation at Catalina Dr. is estimated to be 6.6 feet. A typical cross-section of the grade control structure needed at this location is shown on Figure 9.8. Existing grade control structures (6) downstream of Catalina Drive should be inspected annually and after large floods to confirm that they continue to function as intended. The estimate of future degradation at Catalina Drive assume that these structures continue to function.

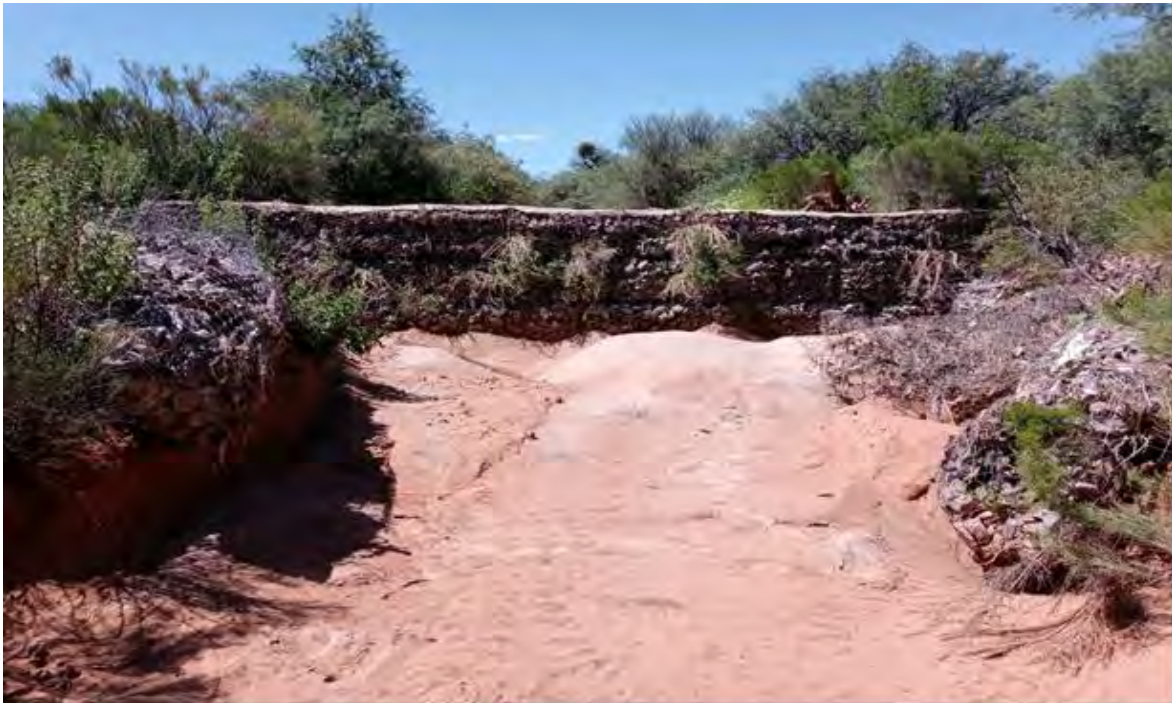
Severe degradation has been occurring along Charleston Wash and the 3rd Street Drainageway between Colombo Avenue and Fry Blvd; the most severe that was observed throughout the community. Depth of channel entrenchment below top of bank elevations is commonly 10- to 15-feet. The channel has a lower width/depth ratio than other similar watercourses which likely contributes to higher flow velocities, sediment transport capacity thus increased erosion rates. Examples of this are shown in Figures 4.8.1-4.8.6 below.

Figure 4.8.2 - Charleston Wash at Sewer Line crossing about 860-feet west of Avenida Escuela

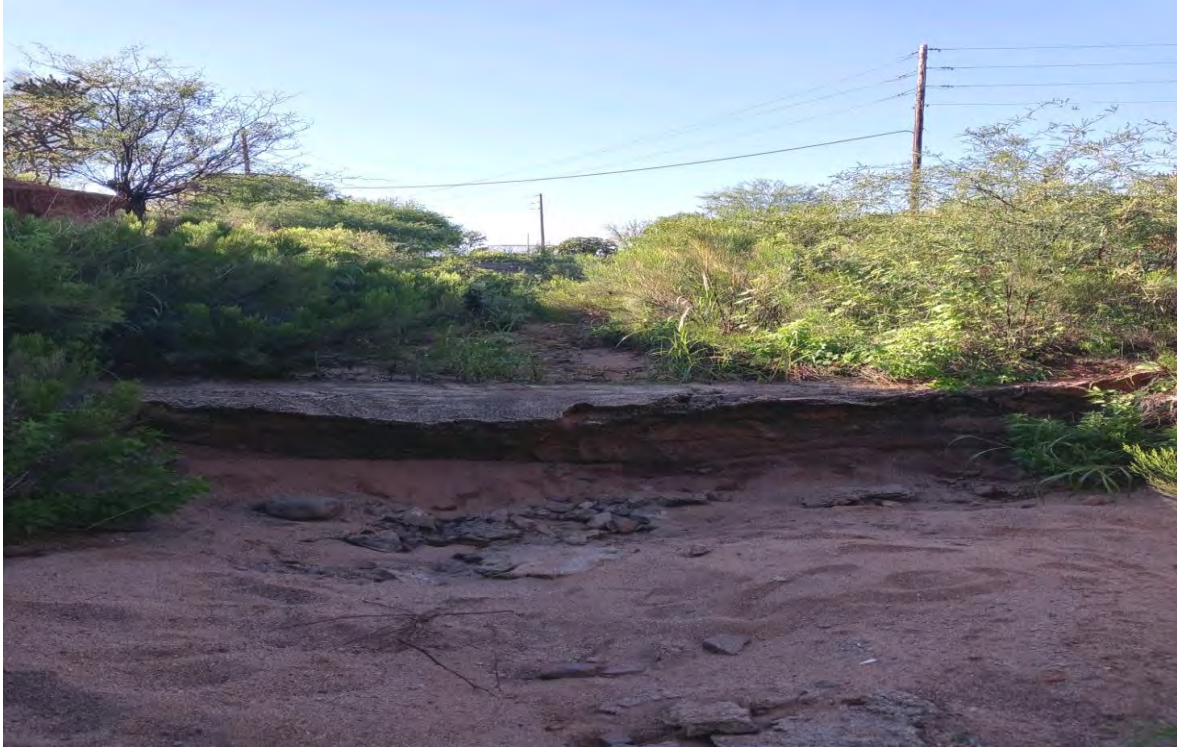
Figure 4.8.5 – Grade Control along the 3rd Street Drainageway about 1000-feet Downstream of Fry Blvd.

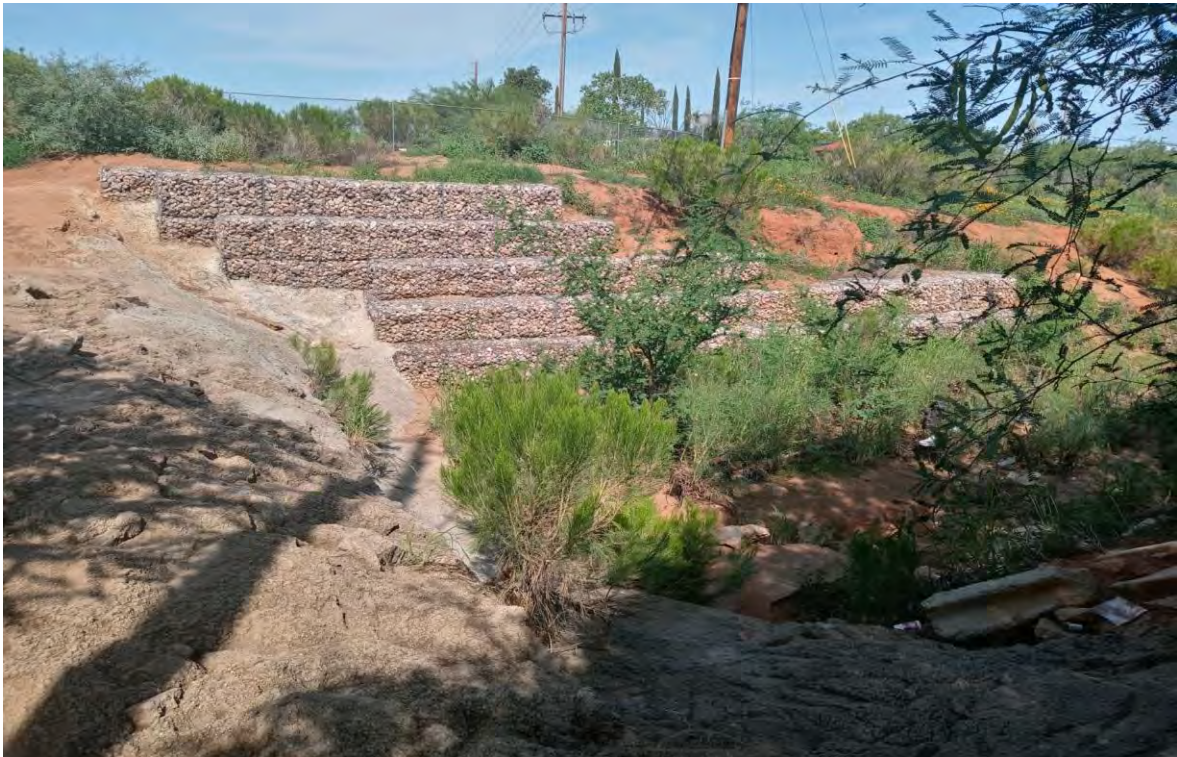
Figure 4.8.6 - 3rd Street Drainageway about 560-feet Downstream of Fry Blvd.

13-feet (see Figure 4.8.6). Gabion bank protection was also installed to control bank erosion adjoining the drop structure. These gabions appeared in good condition during the 2021 field inspections. In 1984/1985 the City constructed a grade control structure at this location to control ongoing degradation. According to the plans, the design drop height was about 3.5 feet and the downstream toe down for bank protection and the cutoff wall depth was 3-feet below channel invert elevation. In 2009, the drop height had increased to 13-feet which has required the City to periodically add concrete to the bottom of the drop to prevent degradation from undermining the structure. Long-term degradation computations which are discussed below, estimate that an additional 8.3 feet of degradation could occur in the future.
