Surface Water Plan (SWP) For City of Sierra Vista

Part 1 – Hydrology & Part 2 - Existing Conditions and Preliminary Analysis of Flood and Erosion Control Alternatives

Prepared for:
City of Sierra Vista
1011 North Coronado Drive
Sierra Vista, Arizona 85635

CMG Project #21-001
May 15, 2023

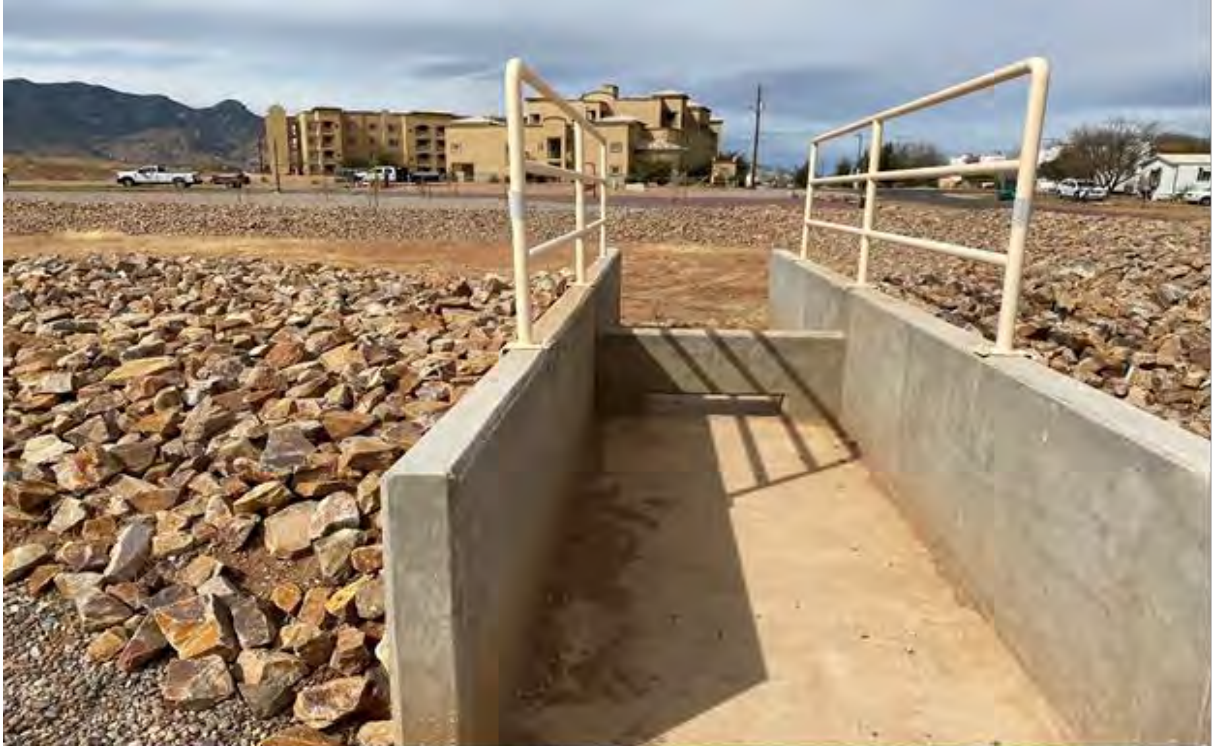
Figure 4.1.6 - Sulger Subdivision - Detention Basin South of Timothy Avenue

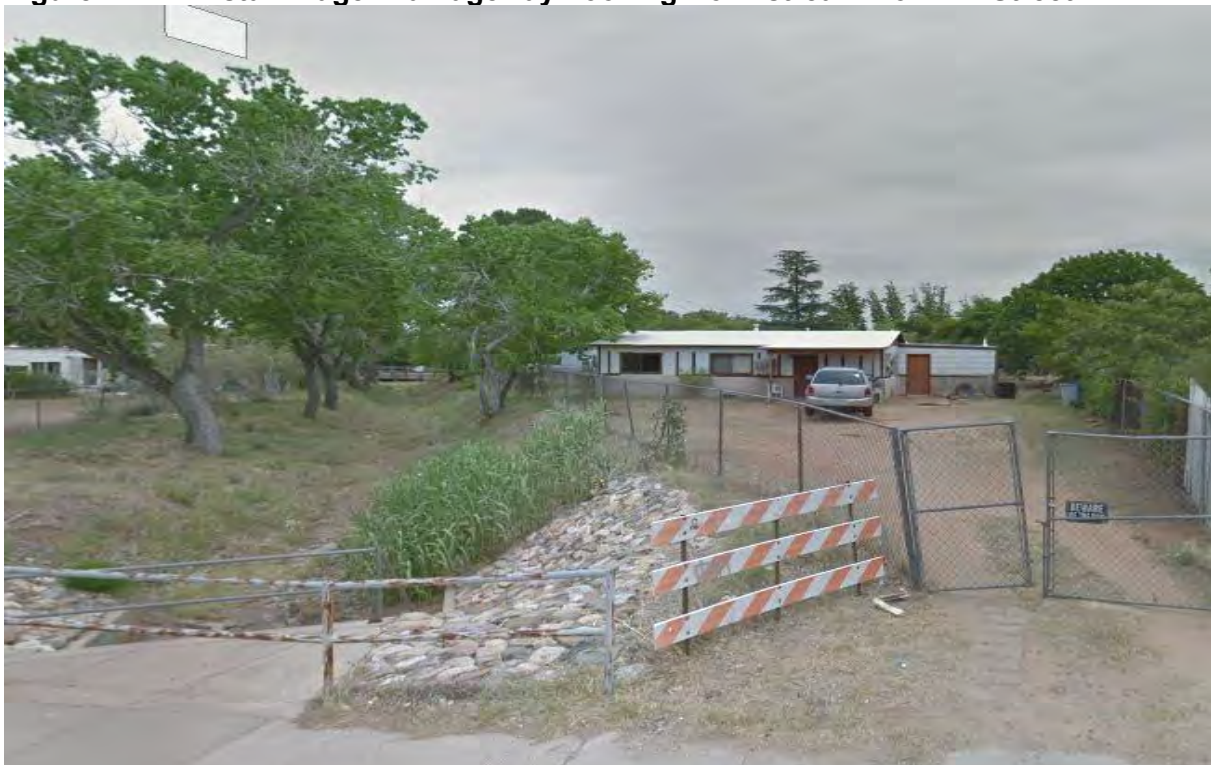
Figure 4.2.4 - Vista Village Drainageway Looking Downstream from 2nd Street

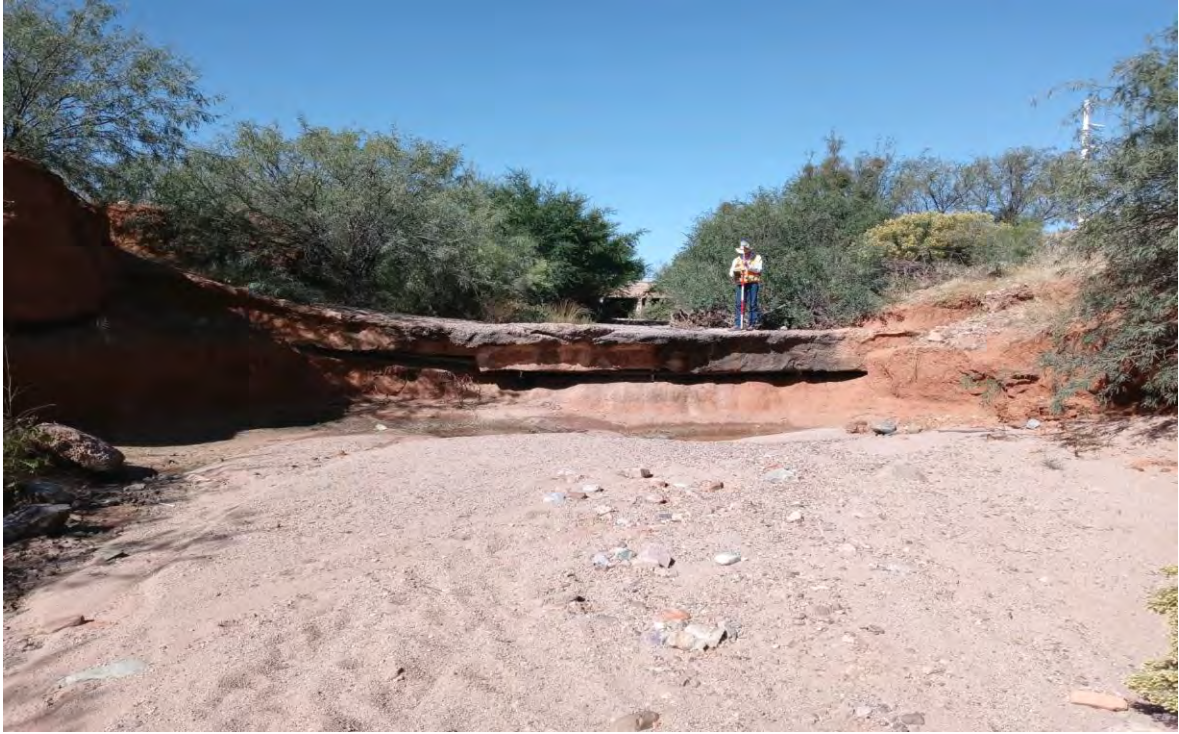
Severe degradation has been occurring along Charleston Wash and the 3rd Street Drainageway between Colombo Avenue and Fry Blvd; the most severe that was observed throughout the community. Depth of channel entrenchment below top of bank elevations is commonly 10- to 15-feet. The channel has a lower width/depth ratio than other similar watercourses which likely contributes to higher flow velocities, sediment transport capacity thus increased erosion rates. Examples of this are shown in Figures 4.8.1-4.8.6 below.

Figure 4.8.3 - Charelston Wash Grade Control about 200-feet downstream of Coronado Drive

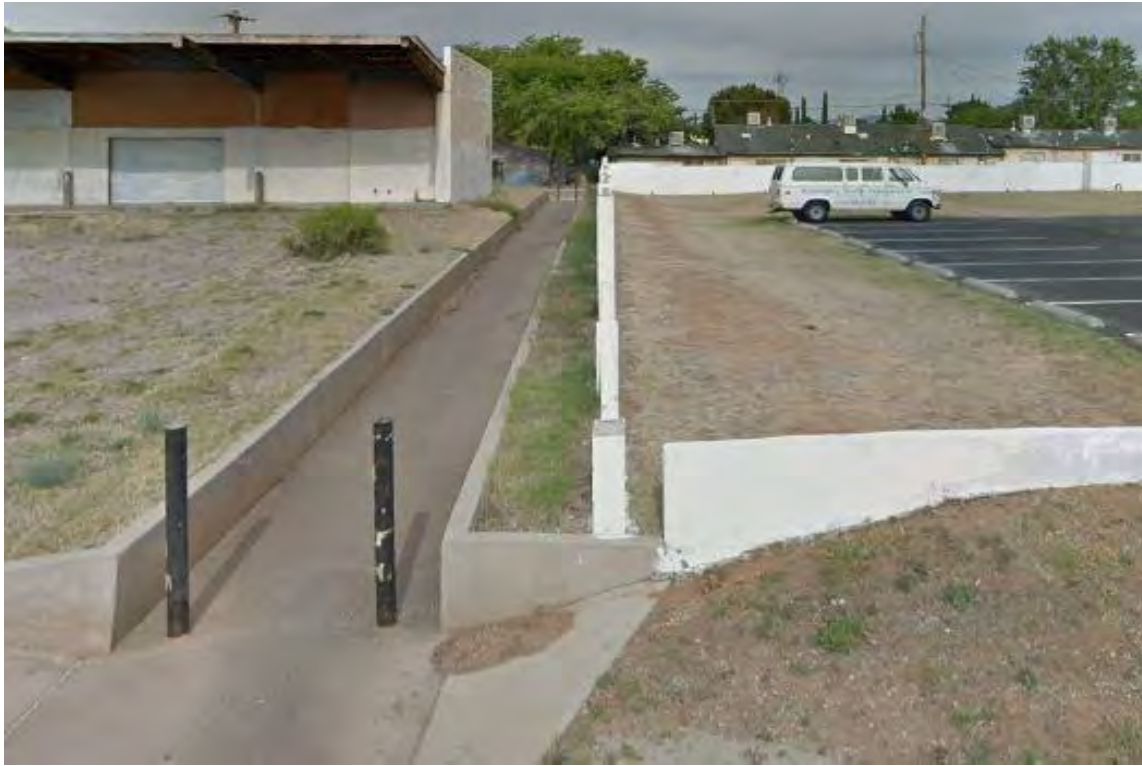
A 5-foot wide concrete channel was constructed to accept stormwater from Carmichael Avenue and deliver it to the 66-inch diameter storm drain but this channel is insufficient to contain more than a small amount of flow. As such, most of the flow spreads onto the adjoining properties as it drains east toward the storm drain inlet. Overflows from the storm drain continue north through residential lots to Canyon Drive, then continue as overland flow until it reaches the Vista Village Drainageway at 2nd Street. The approximate floodplain limits for the area between the storm drain inlet and outlet are shown on Figure 9.2.

Figure 9.3 - 5-ft Wide drainageway from Carmichael Avenue to 66-inch Storm Drain Inlet

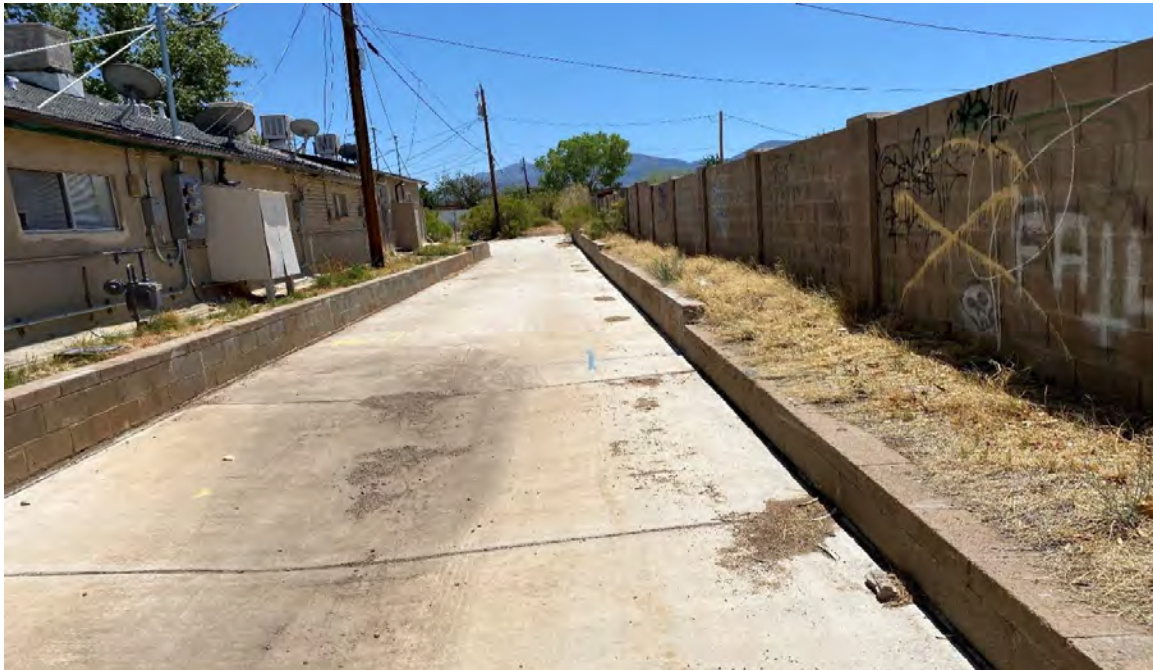
Figure 9.4 - Channel Connecting Fab Ave Drainageway to 66-inch Storm Drain Inlet
